Workplace Health and Safety Hazard Alert

Metal Lathes

15 May 2012

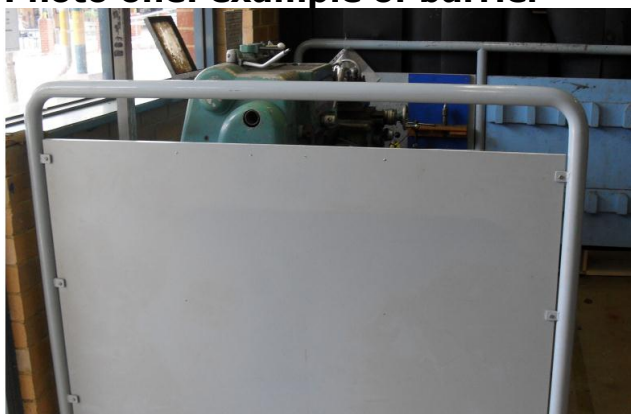
Photo one: example of barrier

- Where bar stock is required to protrude through the outer headstock spindle ensure suitable pedestrian barriers are in place and a risk assessment has been conducted especially with the length and diameter of bar stock in mind.
- Ensure that suitable barriers are in place to prevent students not using the lathe from entering the area unnecessarily and that students using the lathe are adequately supervised.
- Ensure employees and students understand and follow the Safe Work Procedure for Metal Lathes and are deemed competent in the use of the metal lathe.
- Ensure appropriate Personal Protective Equipment (PPE) is worn whilst operating the lathe e.g. safety glasses.

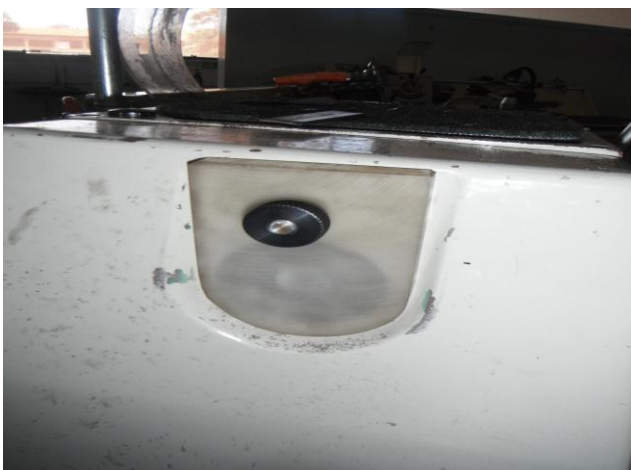
Photo two: example of headstock spindle cover

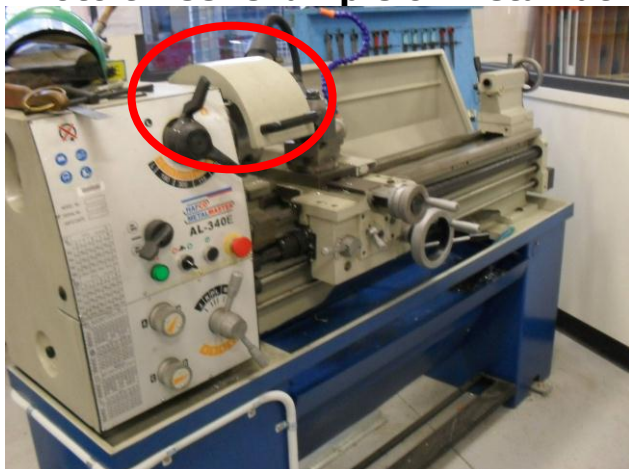
Photo three: example of metal lathe with chuck guard

- Conduct a risk assessment using the [Plant and Equipment Risk Management Form](#) for all metal lathes in their workplace and document appropriate [Safe Work Procedures](#).
- Display Safe Work Procedure next to the metal lathe.
- Ensure that a chuck guard with interlocking is installed.
- Ensure that metal lathes are positioned in areas that have little or no traffic.

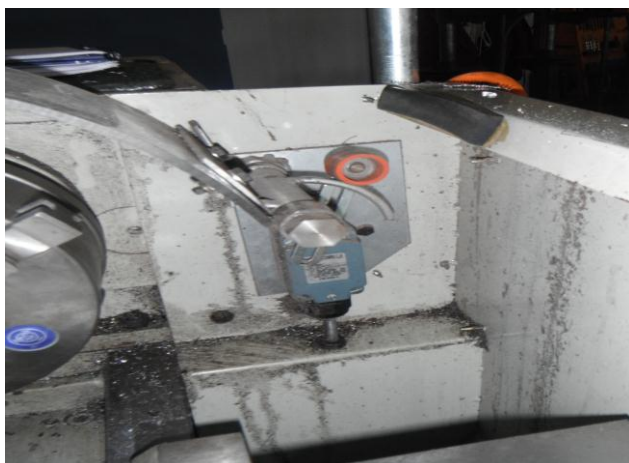
Photo four: side view of chuck guard with interlock
